# **Kolomoki Mitigation Bank, Spring Creek Mitigation Area**

## **Third Year Stream Monitoring Report**

**January 2012 through December 2012**

**USACE File Number 200410120**

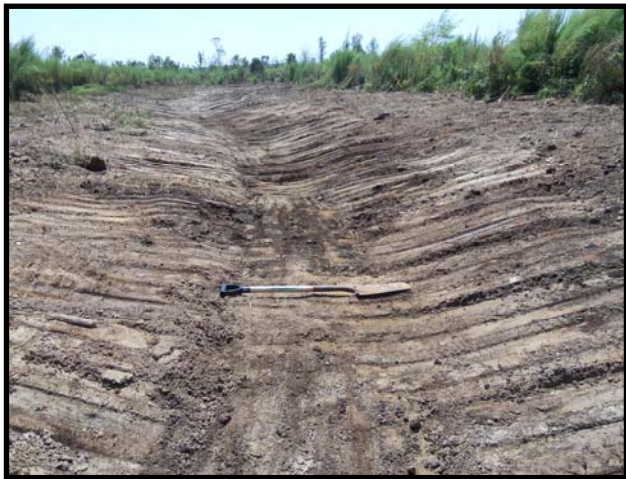
Photo 1: Standing at the northern section of T1B overlooking newly worked channel, facing downstream (early January 2012).

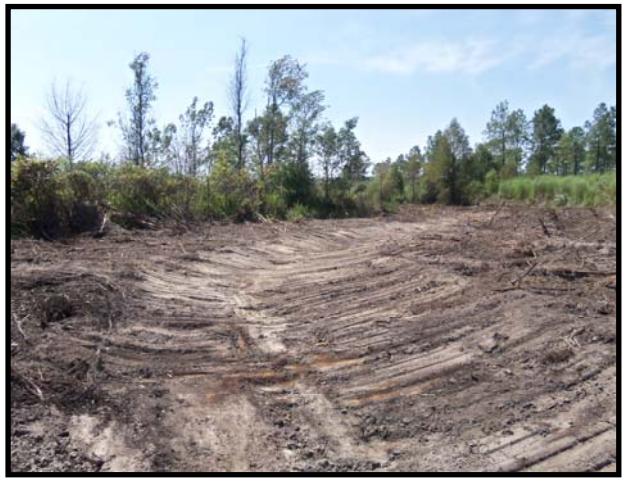
Photo 2: Standing at T1B after initial construction work along meander, facing downstream (early January 2012).

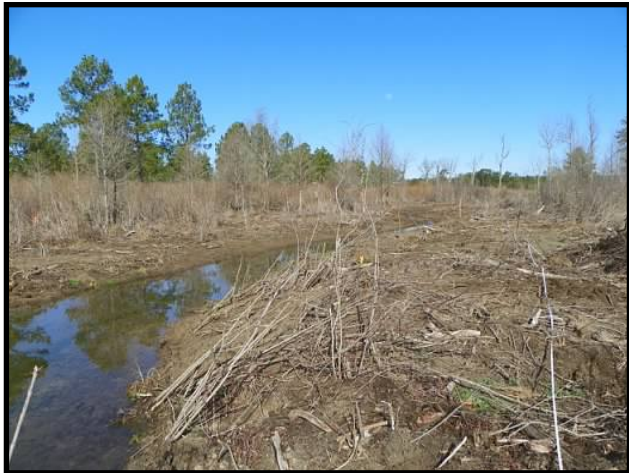
Photo 3: Standing at the right bank of T1-B overlooking the meander apex, facing upstream (January 30, 2012).

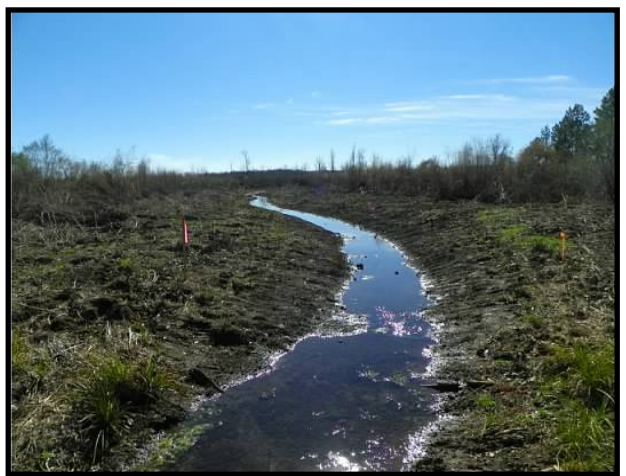
Photo 6: Small riffle located within T1-B after final construction (February 2012).

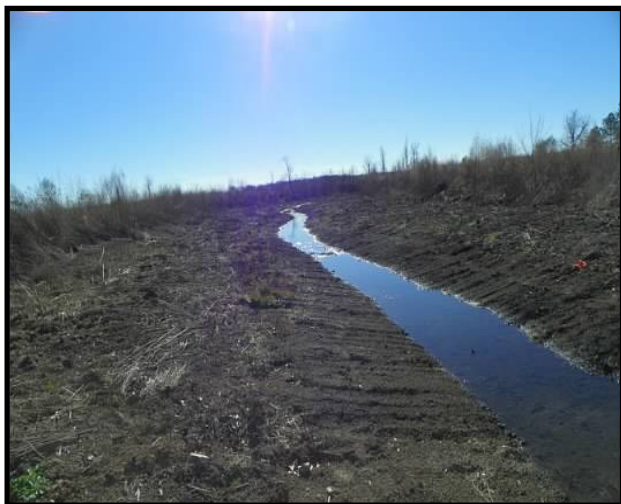
Photo 7: T1-B the day before bare-root seedlings are planted (February 2012).

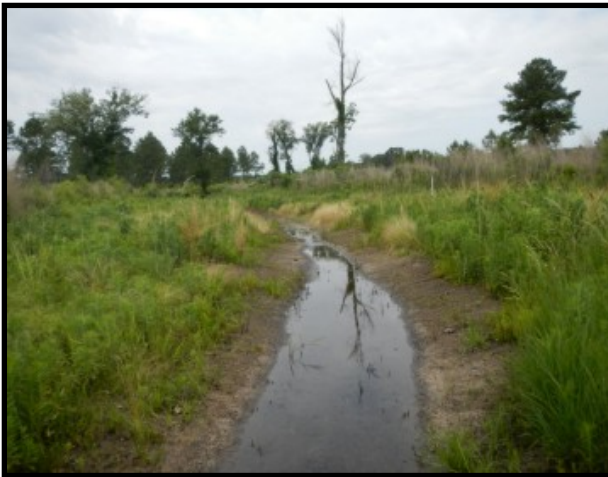
Photo 12: Upper T1-B after construction and planting with herbaceous vegetation growing within the riparian buffer (May 2012).

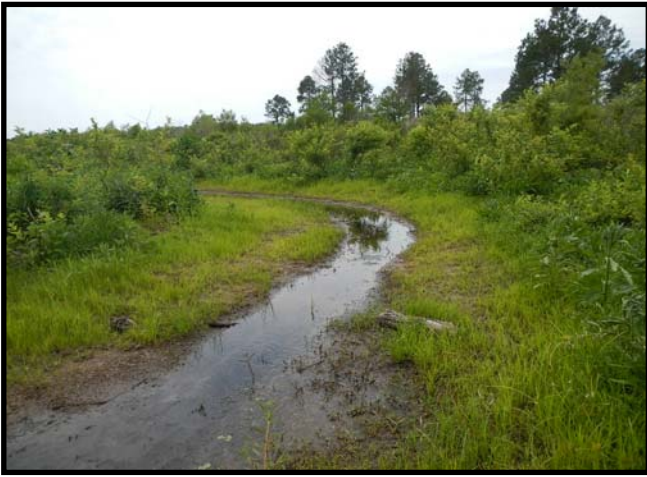
Photo 13: Lower T1-B after construction and planting with herbaceous vegetation growing within the riparian buffer (May 2012).

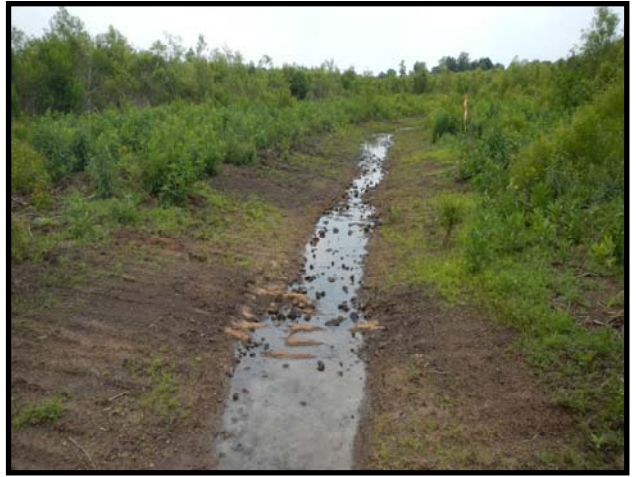
Photo 14: Stair-step riffle area within T1-B (May 2012).

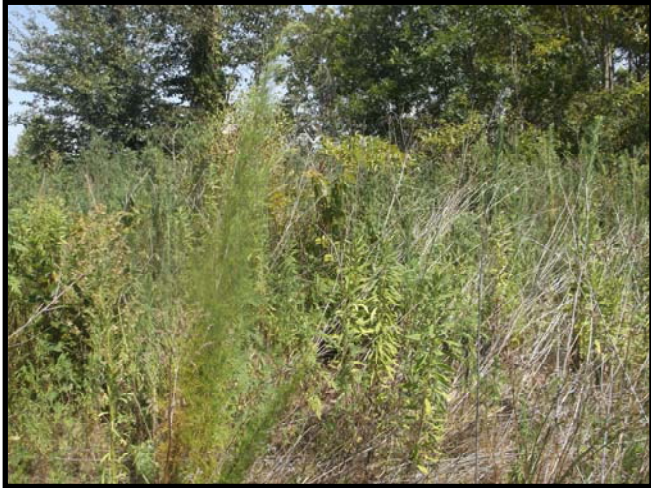
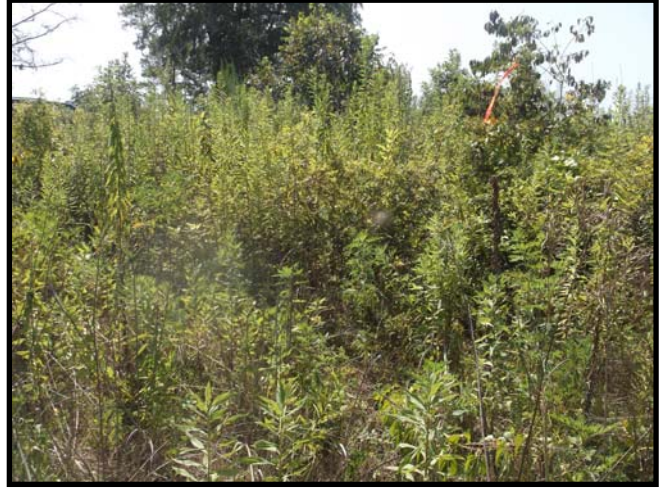
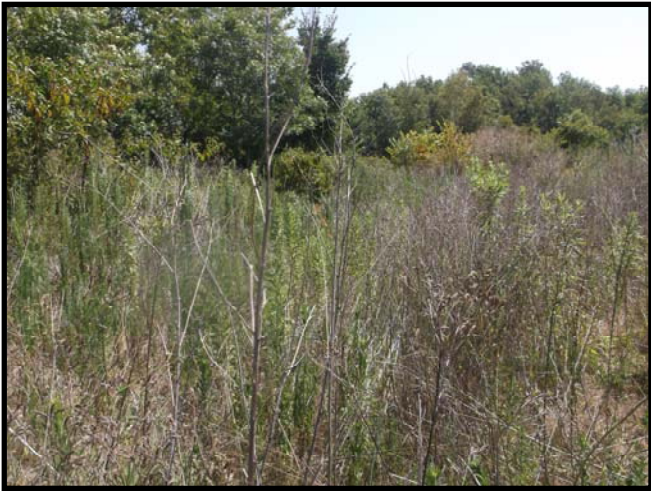
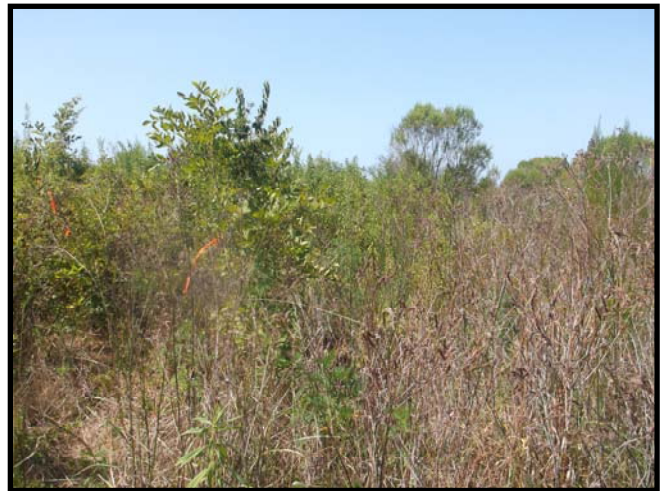
Photo 16: Standing within MS-6, facing north.

Photo 17: Standing within MS-6, facing south.

Photo 18: Standing within MS-6, facing east.

Photo 19: Standing within MS-6, facing west.

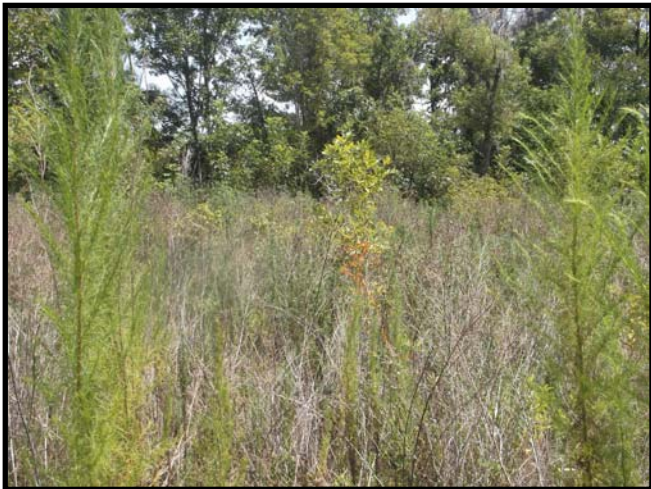
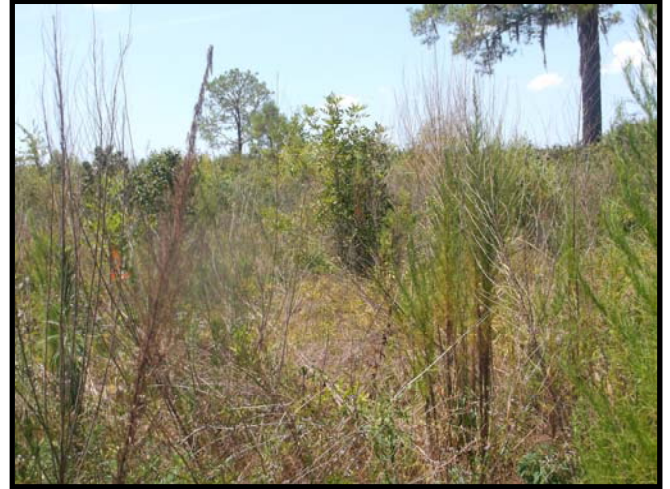
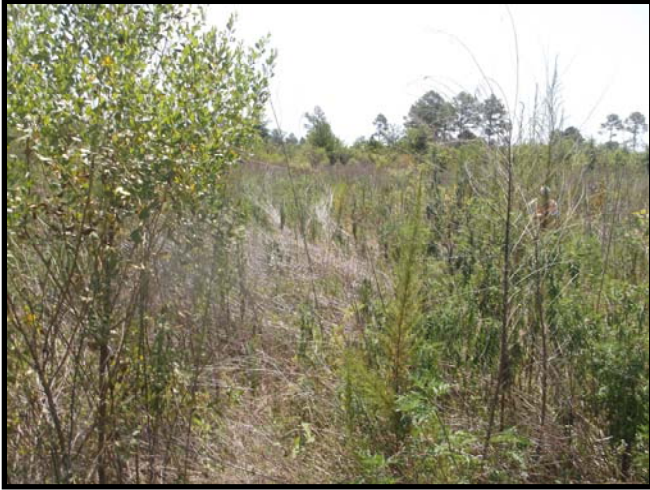
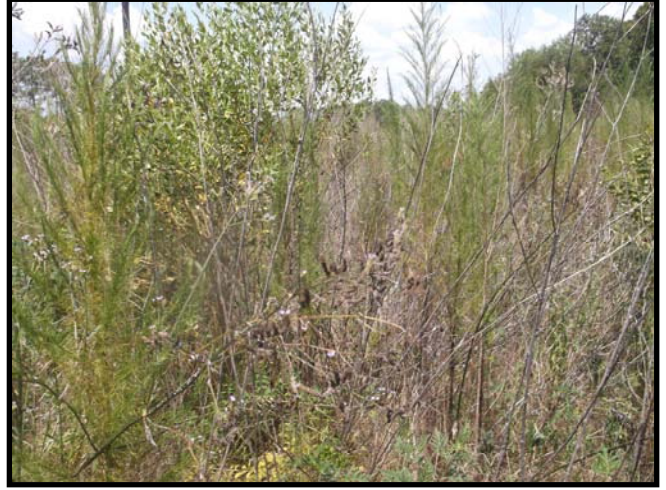
Monitoring Stations 7, 8, 9, 11, and 13 meet or exceed the Y3 density requirements (225 trees/acre). Bald cypress (*Taxodium distichum*) and oaks (*Quercus* spp.) had the most loss of individuals over the last three years. Significant regeneration of green ash (*Fraxinus pennsylvanica*), red maple (*Acer rubrum*), button bush (*Occidentalis cephalanthus*), and bald cypress was observed throughout the SCMA. Currently, there is an average of 1:1 ratio of planted vs. volunteer trees throughout the monitoring stations.

Photo 20: Standing within MS-8, facing north.

Photo 21: Standing within MS-8, facing south.

Photo 22: Standing within MS-8, facing east.

Photo 23: Standing within MS-8, facing west.

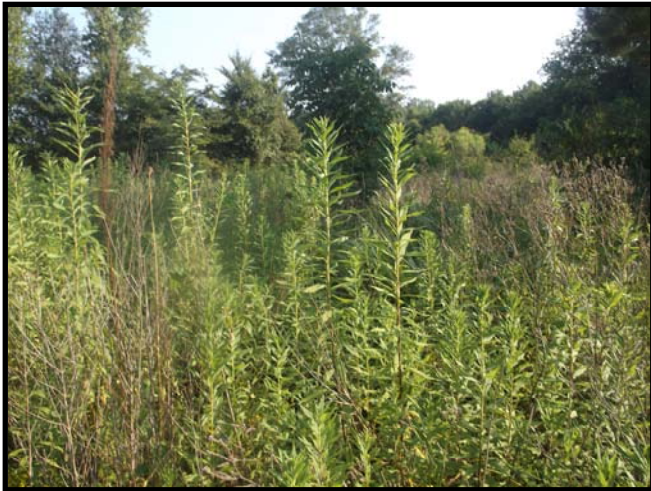
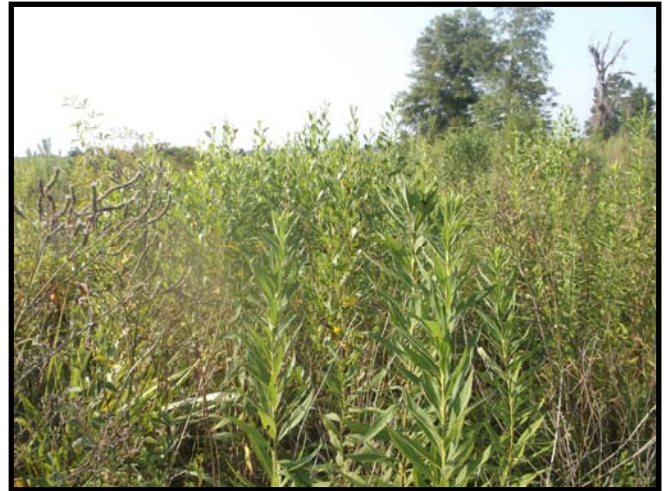
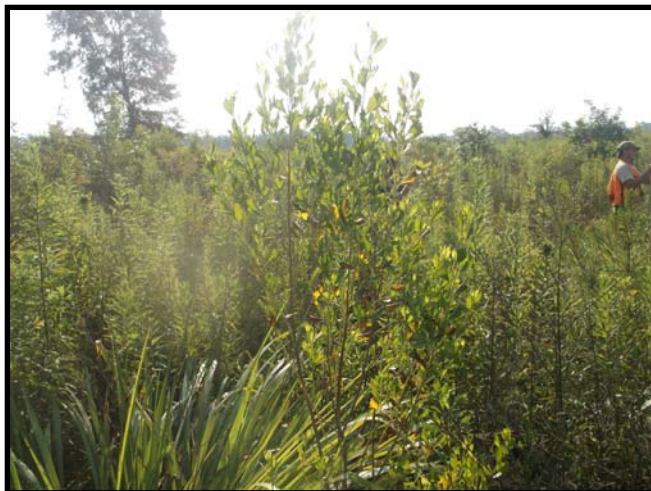
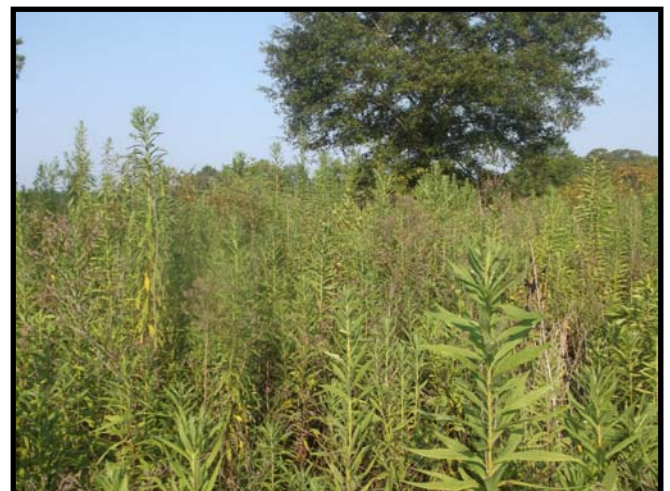
Photo 24: Standing within MS-9, facing north.

Photo 25: Standing within MS-9, facing south.

Photo 26: Standing within MS-9, facing east.

Photo 27: Standing within MS-9, facing west.

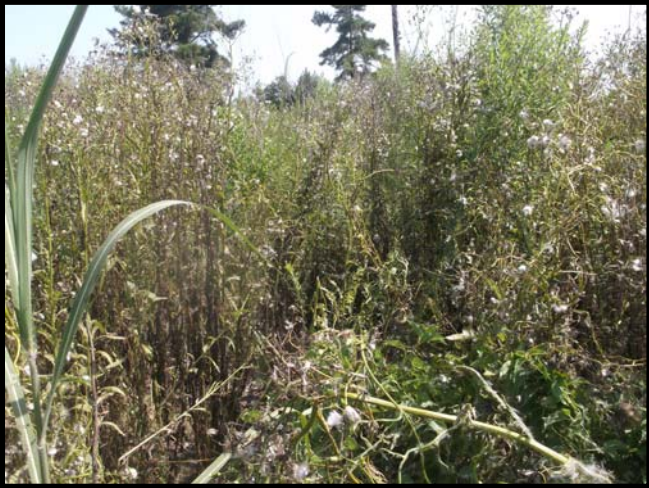
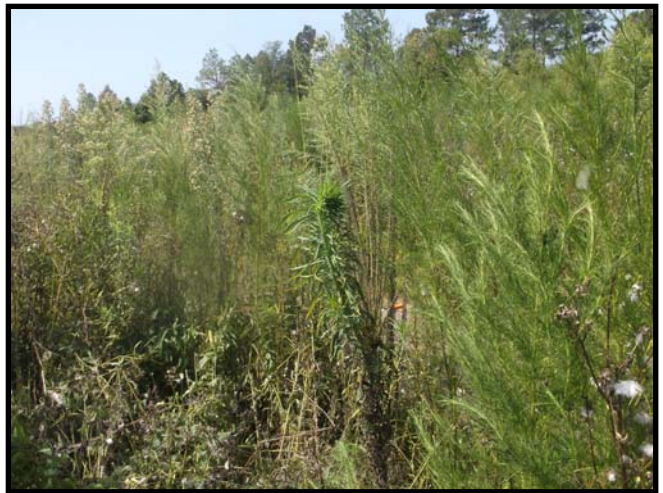
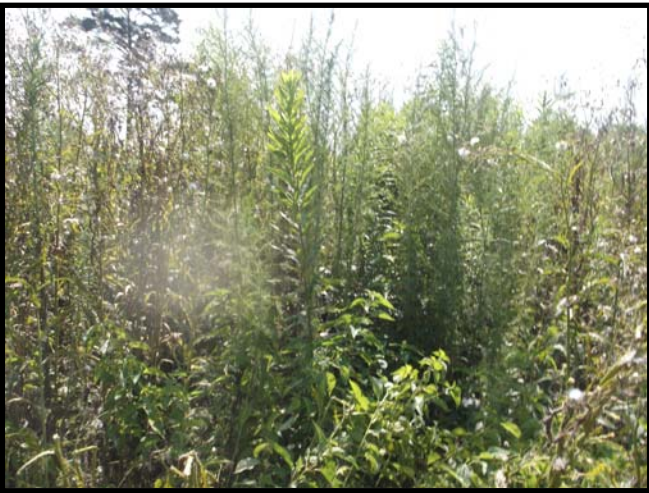
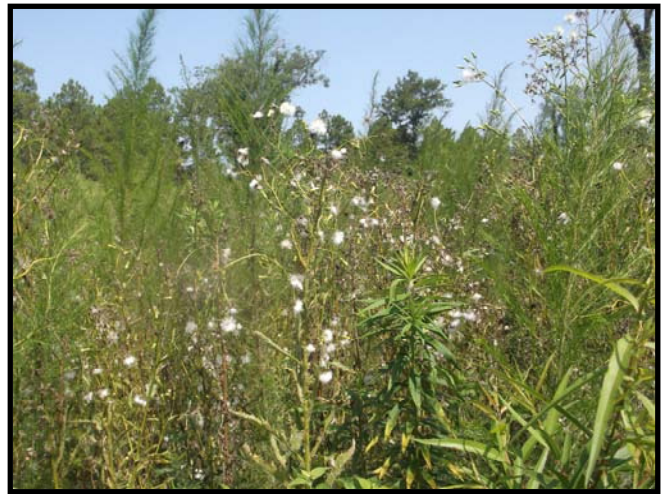
Photo 28: Standing within MS-11, facing north.

Photo 29: Standing within MS-11, facing south.

Photo 30: Standing within MS-11, facing east.

Photo 31: Standing within MS-11, facing west.

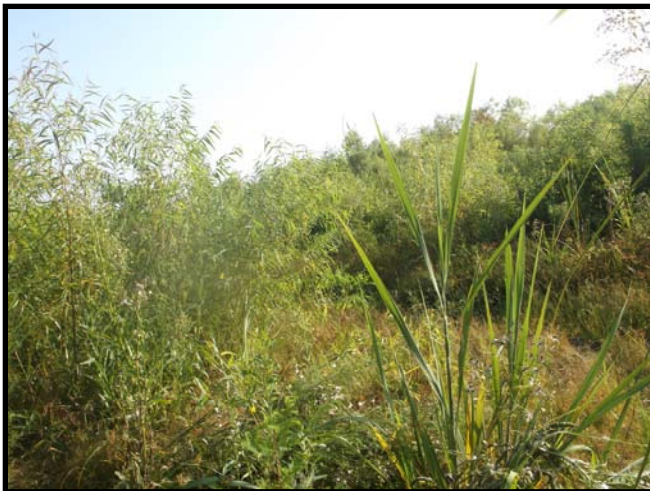
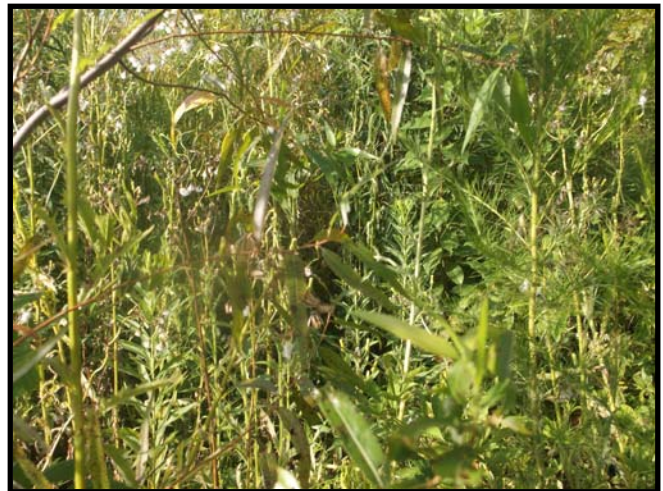
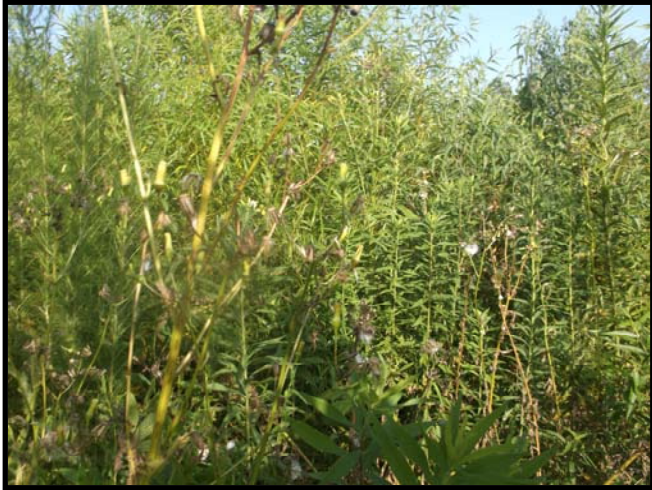
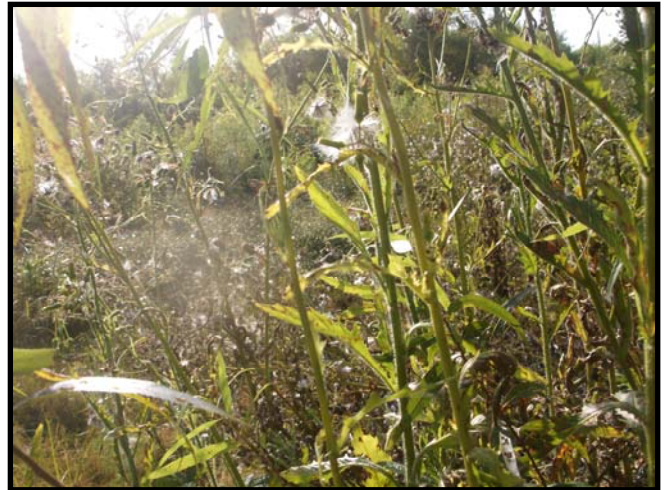
Photo 32: Standing within MS-13, facing north.

Photo 33: Standing within MS-13, facing south.

Photo 34: Standing within MS-13, facing east.

Photo 35: Standing within MS-13, facing west.

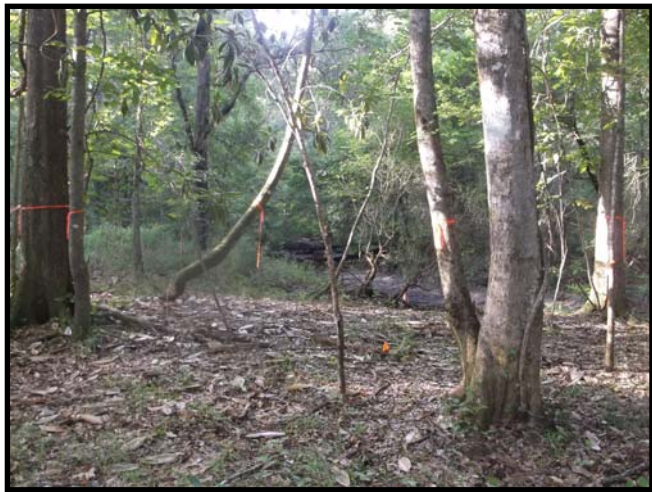
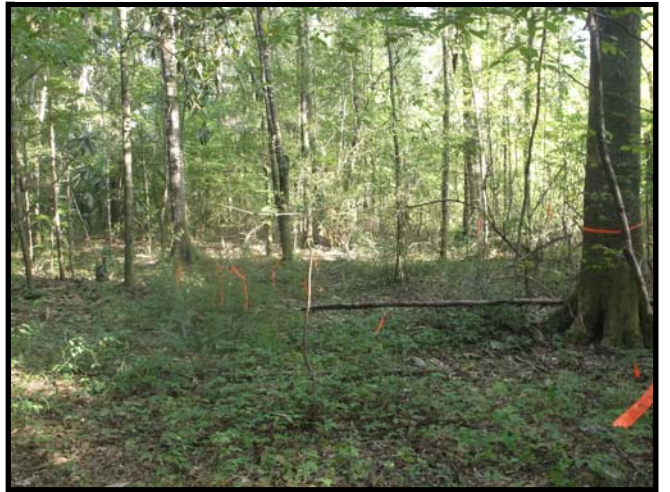
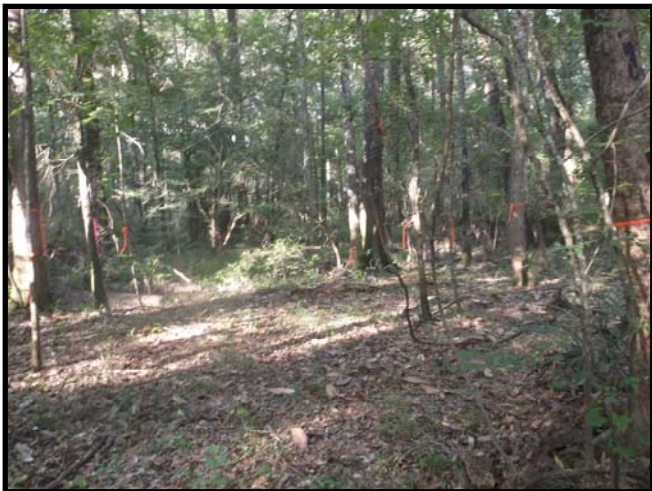
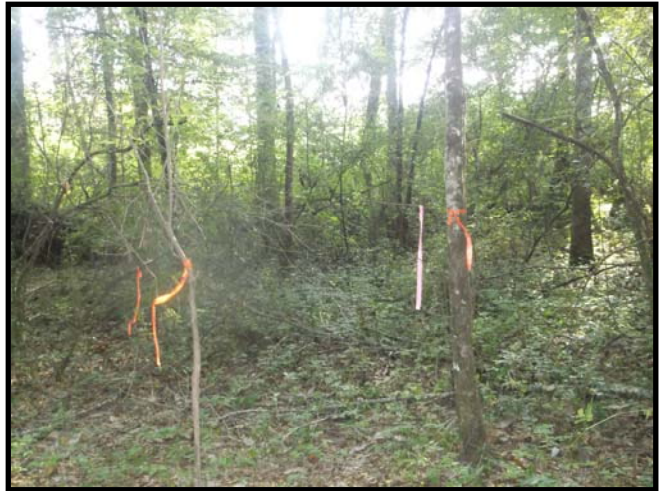
Photo 36: Standing within Reference Station R-3, facing north.

Photo 37: Standing within Reference Station R-3, facing south.

Photo 38: Standing within Reference Station R-3, facing east.

Photo 39: Standing within Reference Station R-3, facing west.
